Tracking Fish Environments with an Autonomous Underwater Vehicle

E80: Section 4, Team 5 - May 1, 2018

Abstract—This report details the creation of an autonomous underwater vehicle that can navigate to an underwater acoustic beacon and collect data about the water surrounding the beacon. The beacon and vehicle simulate fish tracking, with the beacon representing an acoustic tag on a fish and the vehicle representing a tracking device that collects data about the fish environment. The vehicle took temperature and turbidity measurements, as these are valuable indicators of the quality of a fish's environment. In a deployment at Dana Point, the vehicle failed to navigate autonomously towards the beacon due to problems with the microphones. The temperature data logged by the AUV was inconclusive, while turbidity varied from 200 to 600 NTU.

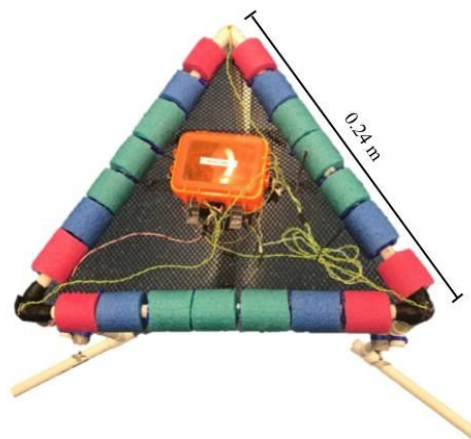
Figure 2: Top view of surface robot.

mesh was attached across the triangular frame to hold the orange waterproof box containing the circuit boards above water, ensuring GPS connectivity. The microphones and thermistor were connected to the motherboard via waterproof penetrators on the box. Another box containing only the turbidity sensor was placed below the water, allowing for the turbidity sensor to always collect accurate data. The final design is shown in Figure 2, with the turbidity sensor box located directly below the orange box. Each side of the triangle is 0.24 meters long to allow for sufficient separation between each microphone.

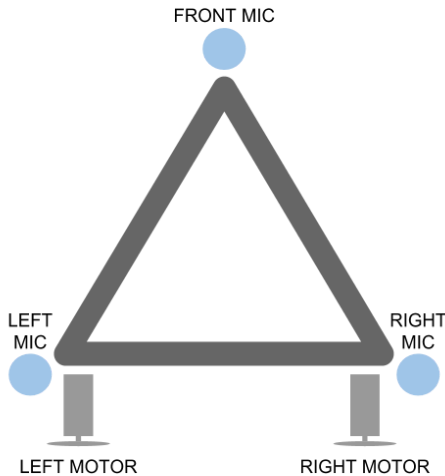
Figure 8: Robot frame with configuration of motors and microphones.

In order to navigate toward the beacon, the robot compared the outputs of the three microphone circuits. The three microphones were designated as the front mic, left mic, and right mic. The two motors were labeled left and right, and corresponded to the left and right microphones, shown in Figure 8. The robot's control system worked to ensure that the point of the triangular frame with the front mic would always point toward the beacon.

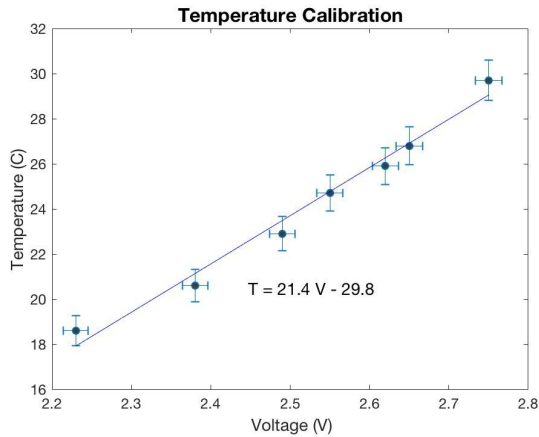
Figure 9: Thermistor calibration curve.

The Teensy reads the voltage across the thermistor rather than the temperature directly. Therefore, a calibration curve was necessary to find the relationship between temperature and voltage. The calibration was created by recording the voltage across the thermistor when immersed in water baths of known temperatures. Specifically, the temperatures of the baths ranged from 10°C to 30°C to account for all temperatures expected during the deployment. The average surface temperature of the water at Dana Point in April ranges from 14°C to 18°C, while the average temperature outside of the water ranges from 15°C to 25°C. The calibration curve was linear as expected, and matched the curve shown on the data sheet [15]. The resulting relationship and equation relating temperature and voltage are shown in Figure 9.

In a laboratory setting, thermistor voltages and temperatures were consistent with the calibration in Figure 9, even when the thermistor was moved from air to water and back again. These tests were conducted in the lab with both tap water and salt water. Furthermore, the same exact thermistor was used inside and outside of the lab, and functioned as expected inside of lab while displaying peculiar behavior outside of lab. Since the thermistor functioned as expected in the lab, it was probably not defective.

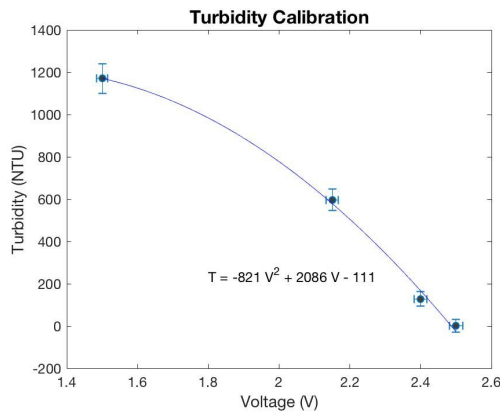
Figure 10: Turbidity sensor calibration curve.

Because the turbidity sensor circuit outputs a voltage, a calibration curve comparing voltage to turbidity was necessary. The standard turbidity unit is Nephelometric Turbidity Units (NTU). The experimental procedure for this calibration was the same as in E80 Lab 3, where a set of solutions of known turbidities were created using evaporated milk and water and were measured using a TU-2016 calibrated laboratory turbidity meter. The calibration trendline was second order, which matched the trendline found in the data sheet, verifying its accuracy [6].

Expected turbidity was more difficult to quantify, but the turbidity of the water in the ocean might range from 1 NTU to 500 NTU, which falls within the values on the calibration curve in Figure 10.

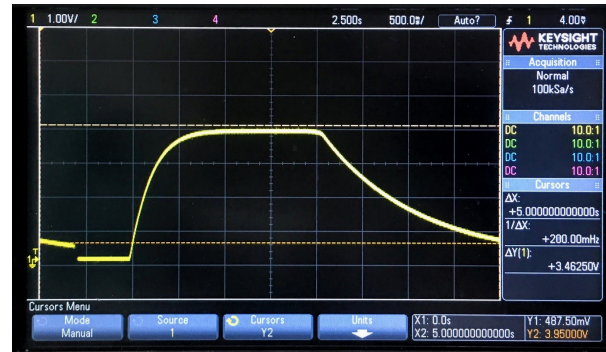
Figure 11: Successful microphone circuit response curve.

Finally, the voltages picked up by each microphone were expected to range from 0 V to 3.5 V, as shown in Figure 11.

The increase in voltage over time as recorded by the oscilloscope follows a first order response. Figure 11 illustrates the expected behavior of the output of the microphone circuit as the signal from the speaker increases in amplitude and subsequently decreases.

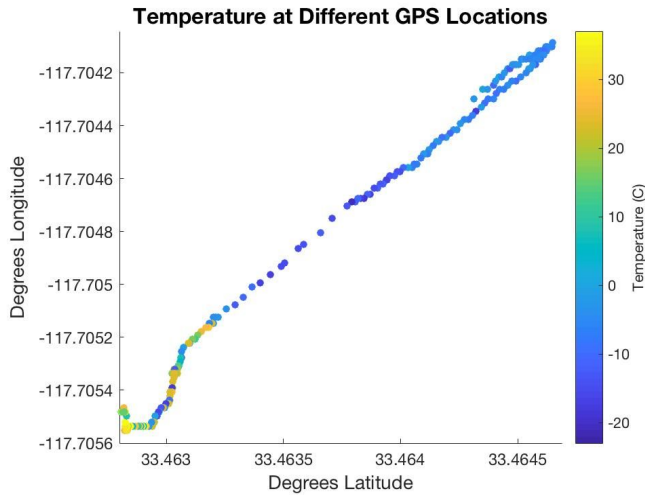
Figure 13-14: Temperature vs. GPS location (top), and the same temperature data vs. time into deployment (bottom). The data in both figures comes from the third deployment.

The biggest difference between thermistor use at Dana Point and in the lab was the time spent in the water. In the lab, the thermistor was kept in the water for a couple seconds, just long enough to record a reading on the multimeter. At Dana Point, on the other hand, the thermistor was kept in the water for several minutes at a time, as evidenced by Figures 13 and 14. It is possible that the thermistor wires were not adequately waterproofed, and that this only became an issue after extended time in the water. If this were the case, the temperature values in the beginning of the deployment (at about 60 seconds) could indicate the true temperature of the water, about 19°C.

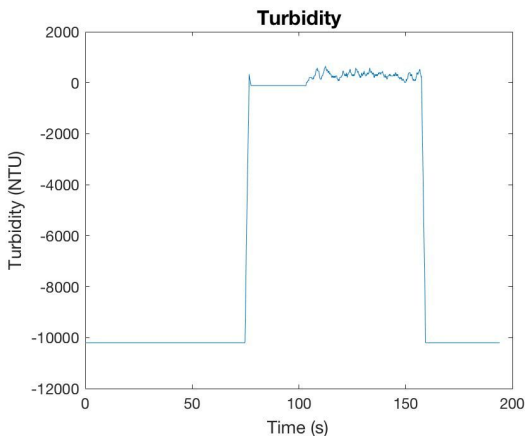
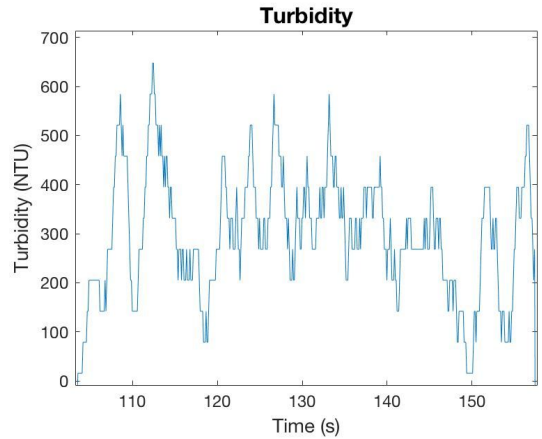
Figures 15-16: Turbidity data in air and in water (top) and just in water (bottom).

The turbidity sensor did not work outside of the water, which is reflected in Figure 15. Before the AUV was placed in the water, the turbidity was, according to the calibration, an unrealistic value of -10,000 NTU. When the AUV was placed in the water, between 75 and 160 seconds, turbidity values jumped to more reasonable levels (Figure 16).

Figure 16 shows that once the AUV was in the water, turbidity mostly fluctuated between 200 NTU and 600 NTU. These are reasonable turbidity values; water samples analyzed in the lab varied from 0 NTU to 1200 NTU. Figure 16 suggests that turbidity varied greatly with from location to location, which is possible if the number of particles and disrupted sediment varied from one location to another. Additionally, strong currents can make water more turbid, so this variability could be explained by the presence of currents in certain areas.

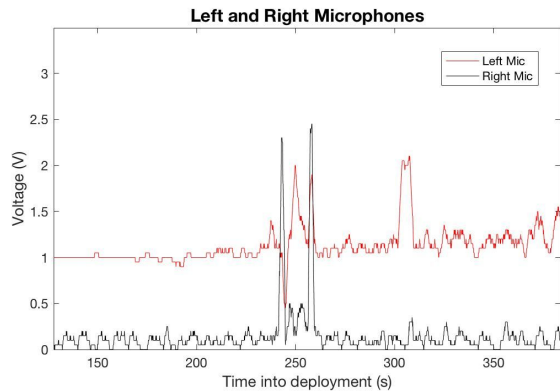
Figure 17: Voltages of left and right microphone circuits in third deployment.

At Dana Point, two of the microphones, the left and right microphones, functioned, as shown in Figure 17. The front microphone circuit output a constant 0 V. With just two microphones working, the control did not fully work; the Teensy detected that the front microphone circuit was always outputting a lower voltage than the left and right microphones, which triggered just one motor to turn on so that the AUV would turn around.

The data in Figure 17 show the left and right microphone voltages when the AUV was in the water. Evidently, the left microphone had a 1V offset, as its voltage was at 1V even when the AUV was far from the beacon and the left microphone should have had a voltage of 0V. When the beacon was brought close to the AUV at about 250s the

microphones appeared to work as expected. The spikes in right mic voltage indicate that the beacon was brought closest to the right mic, while spikes in left mic voltage indicate that the beacon was brought closest to the left mic.

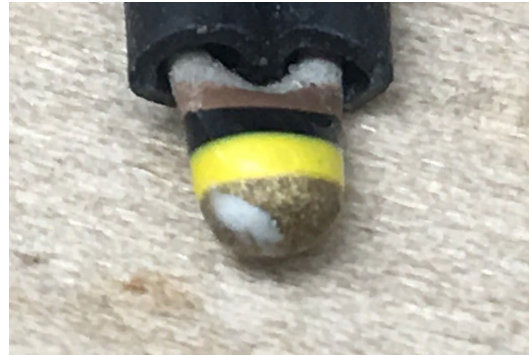
Figure 18: Thermistor with exposed metal wire near heat shrink.

The thermistors showed a negative temperature from the deployment at Dana Point. The calibration curve created in class was linear, as expected, so it was not a likely source of error. Upon further inspection of the thermistor, it became clear that the heat shrink insulation was not as waterproof as previously thought, and some of the metal wire was exposed and slightly corroded.

This suggested that the unexpected temperatures may be related to saltwater exposure at Dana Point. When the thermistor was placed into a freshwater solution at about 20°C, the thermistor accurately measured about 110 kΩ. Per contra, when the thermistor was placed into a saltwater solution (of 35 parts per thousand or 35 grams per kilogram, like that of ocean water), the resistance slowly dropped until it appeared to stabilize at about 50 kΩ [20]. This suggested that the issue with the thermistor was related to saltwater exposure.
